What is a TRUE 5200 bottom?

by Don Danenberg

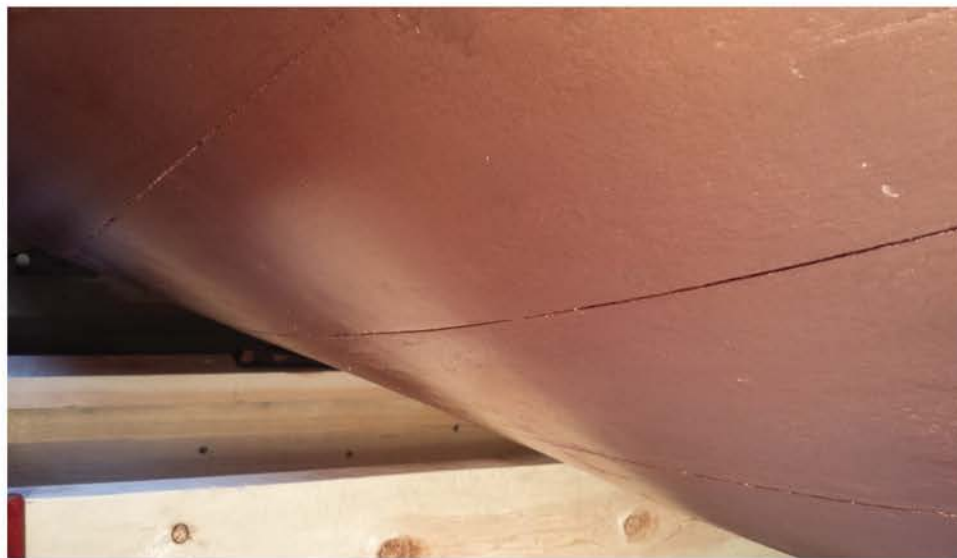
A well-used, 10-year old 'shortcut' 5200 bottom showing open seams. The owner was billed for 24-tubes of 5200, obviously not enough. Also, no barrier coat primer.

The biggest problem I've seen here is inadequate amounts being used. Where I recommend 40 to 60 tubes for just the bottom plank installation, these troubled guys reported they had been billed for 24 tubes. This is simply not enough product to fill all voids. Okay, so you saved a few hundred bucks, but compromised the entire operation?

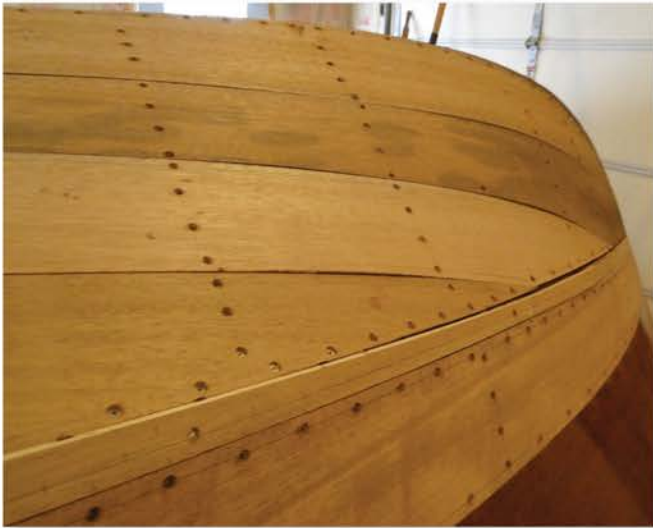
This 'shortcut' 5200 bottom shows almost no rubber filling seams; also stainless screws? Do not expect longevity here.

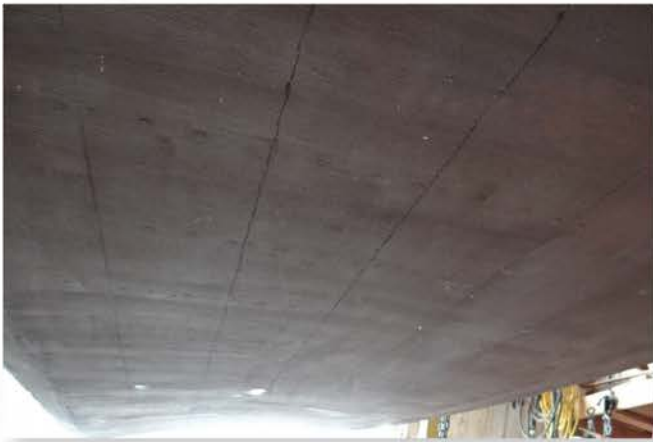
This 10-year old 'shortcut' 5200 bottom had never been put in the water. 24-tubes of rubber were billed and *no* CPES or barrier coat primer. Note how plank shrinkage cracked seams and left bung putty proud.

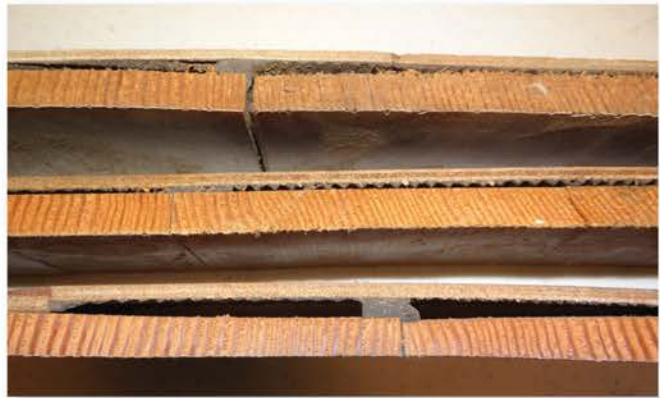
Sections from a failed 3M-4200 bottom. The "professional" restorer used a woefully inadequate amount of 4200 (20 tubes), which set too early (note trowel tooth marks) and he also skipped the use of intermediate frames, which would have pulled the layers together.

4200 sets in 4 hours, nowhere near enough time to get thousands of screw-holes drilled and set before it sets up!

Another problem I've seen in troubled bottoms is the restorer's decision to *not* include the intermediate frames, claiming they are not necessary because the rubber is there. The problem with this is that the intermediate frame screws *are* necessary to pull the planking layers into contact before the rubber sets.

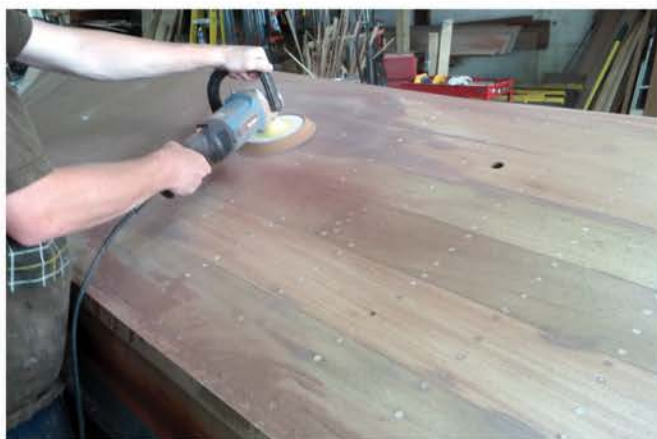
Complete removal of incorrect paint coatings to allow applications of CPES, barrier coat primer, and bottom paint.

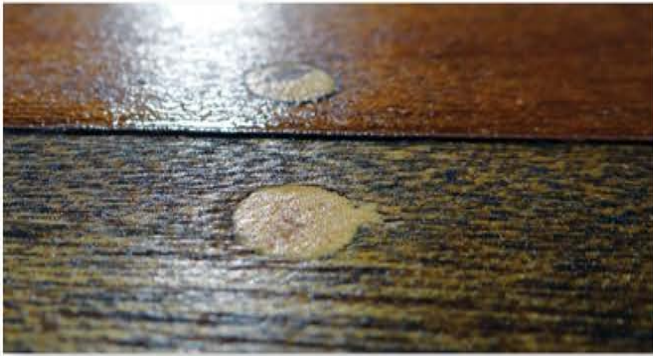
Some tiny gaps are too small to force 5200 into. Three quarts of CPES caused the wood to swell, then set in that condition. Note the raised rubber.

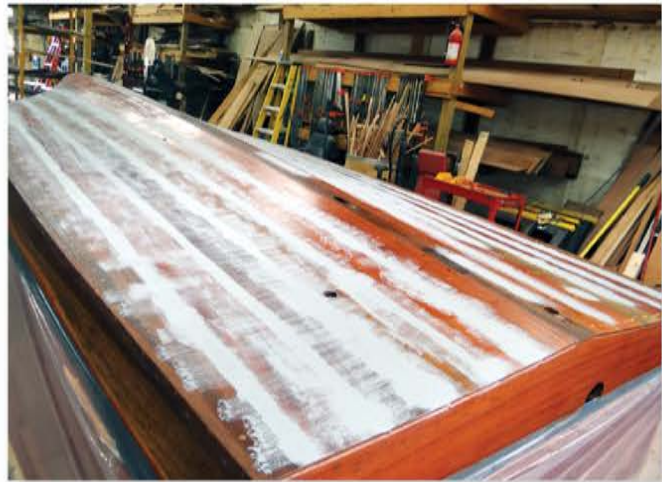
Any remaining tiny gaps, too small to force rubber into, are filled with barrier coat primer by brushing perpendicular to the seams with a stiff brush. Four to five barrier coats follow, then 2 bottom paint.

This product's instructions call for a 10-mil thickness, usually 4-6 rolled-on coats (no sanding between coats) or two gallons for the average 20-footer. If your restorer tells you that 2 coats is enough, he is wrong.

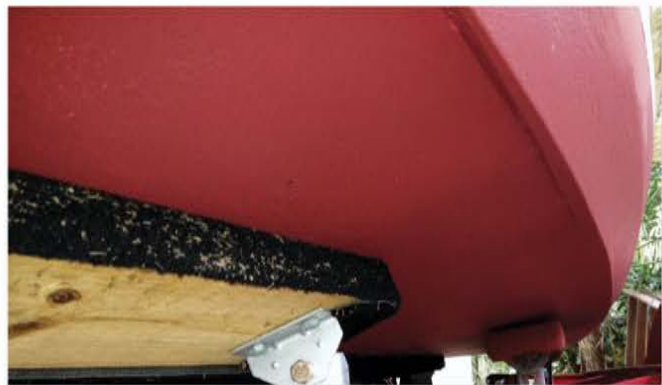
A TRUE 5200 bottom, well used by three owners, 21-years after construction and refresher bottom paint twice.
